NASA/TM—2004-212303

# Durability Assessment of Gamma TiAl— Final Report

Susan L. Draper, Bradley A. Lerch, J. Michael Pereira, and Kazuhisa Miyoshi  
Glenn Research Center, Cleveland, Ohio

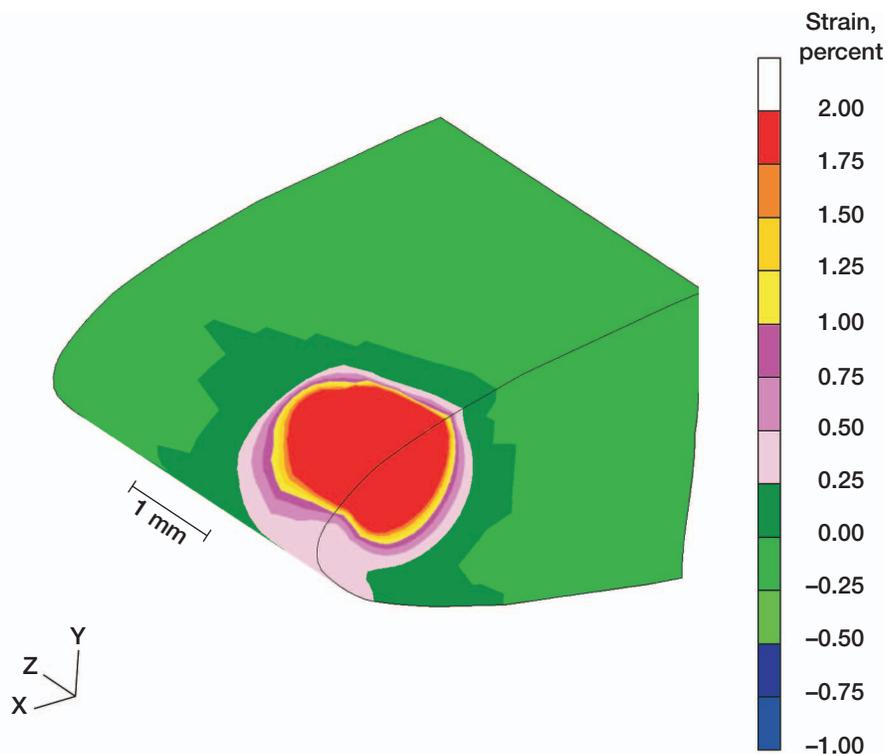
Figure 27.—Prediction of von Mises plastic strain on front side of Ti-48-2-2 after low-energy impact (specimen 008-10-3).

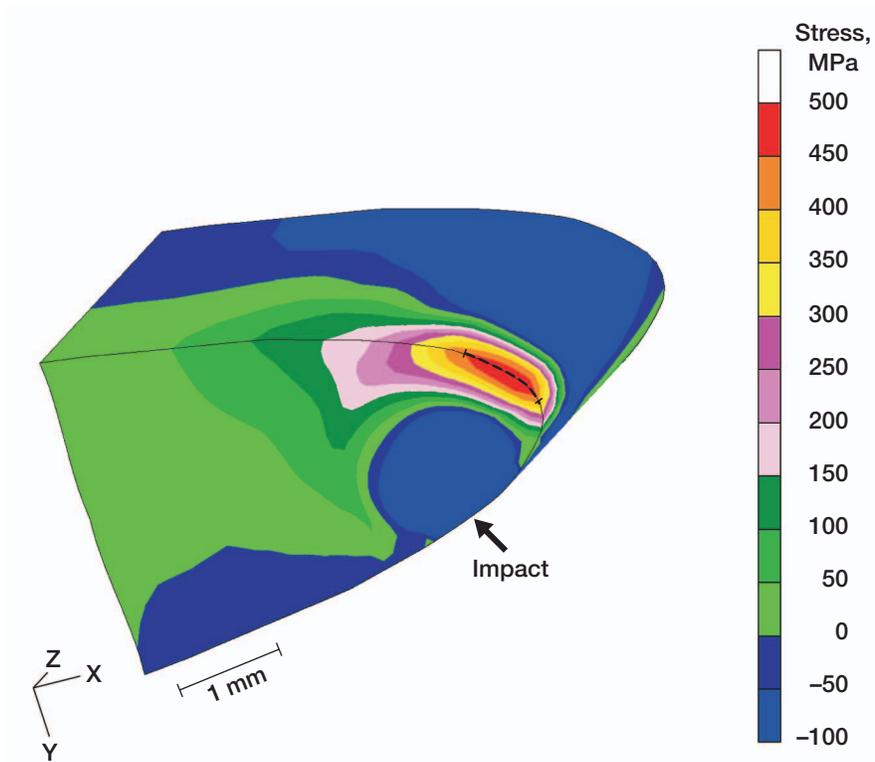
Figure 28.—Prediction of z stress on back side of Ti-48-2-2 after low-energy impact (specimen 008-10-3). Dashed line is cracking zone.

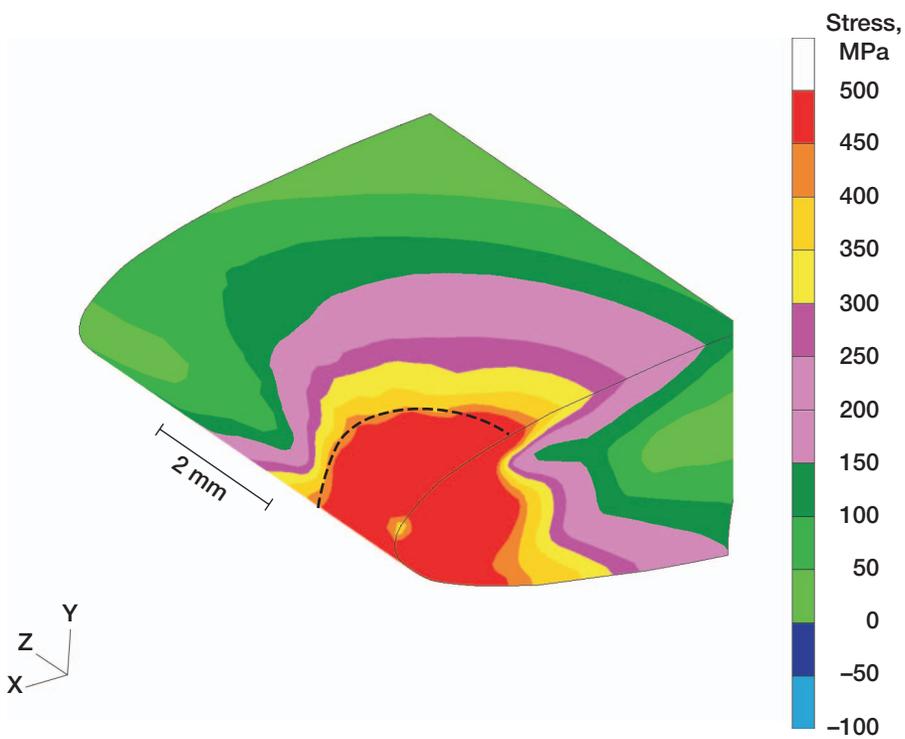
Figure 29.—Prediction of von Mises stress on front side of Ti-48-2-2 after intermediate-energy impact (specimen 005-08-3). Dashed line is cracking zone.

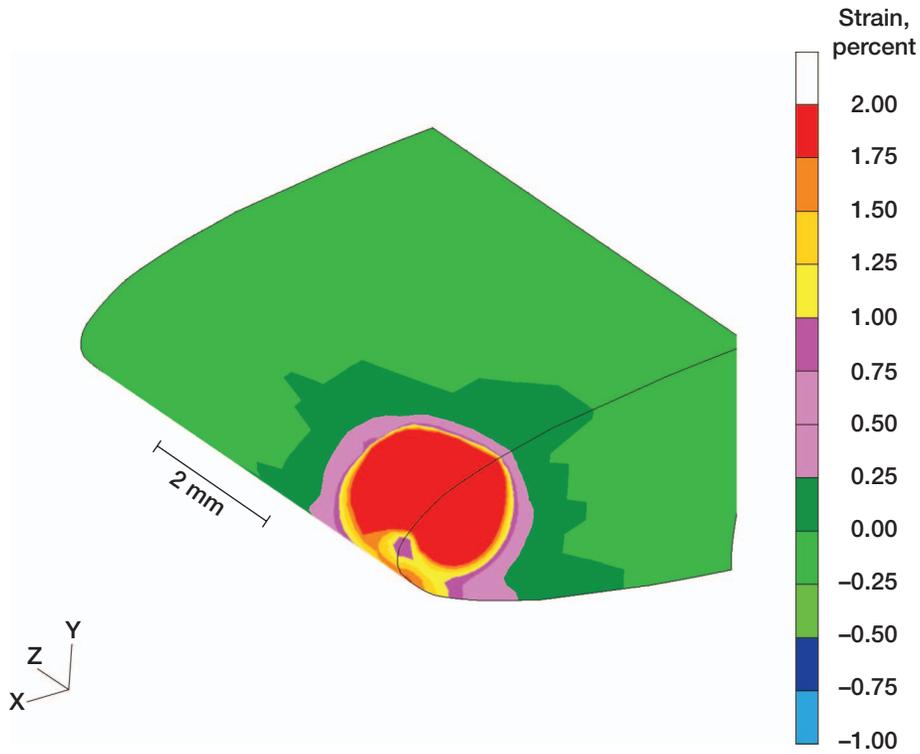
Figure 30.—Prediction of von Mises plastic strain on front side of Ti-48-2-2 after intermediate-energy impact (specimen 005-08-3).

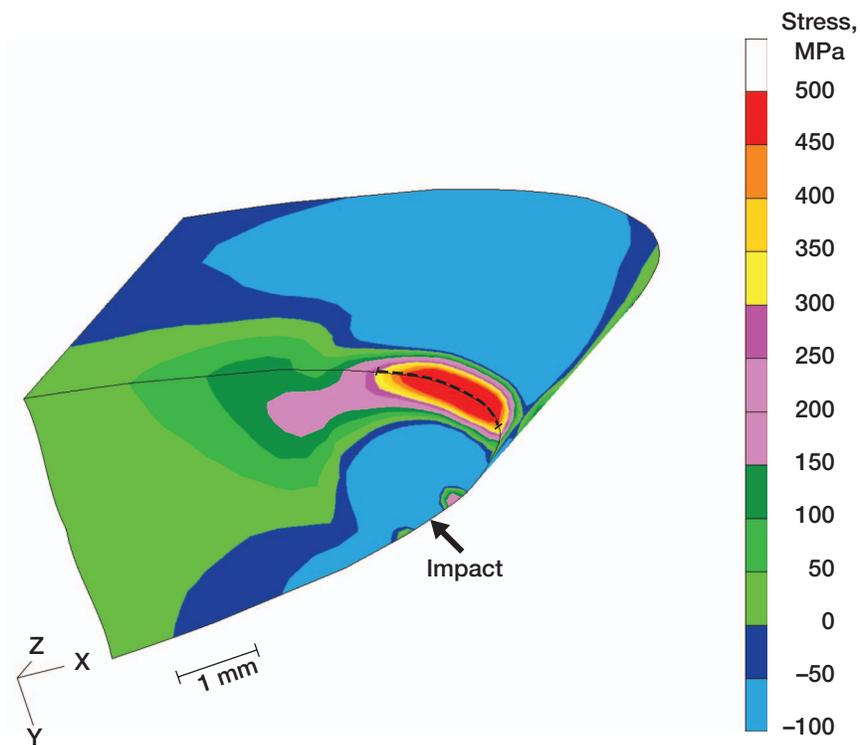
Figure 31.—Prediction of z stress on back side of Ti-48-2-2 after intermediate-energy impact (specimen 005-08-3). Dashed line is cracking zone.

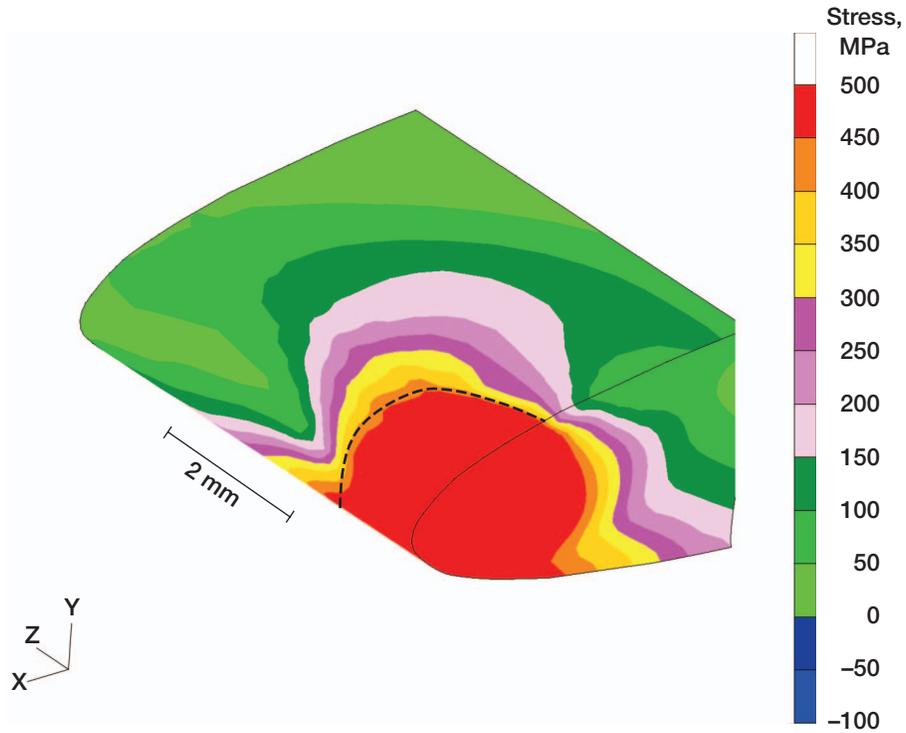
Figure 32.—Prediction of von Mises stress on front side of Ti-48-2-2 after high-energy impact (specimen 009-08-2). Dashed line is cracking zone.

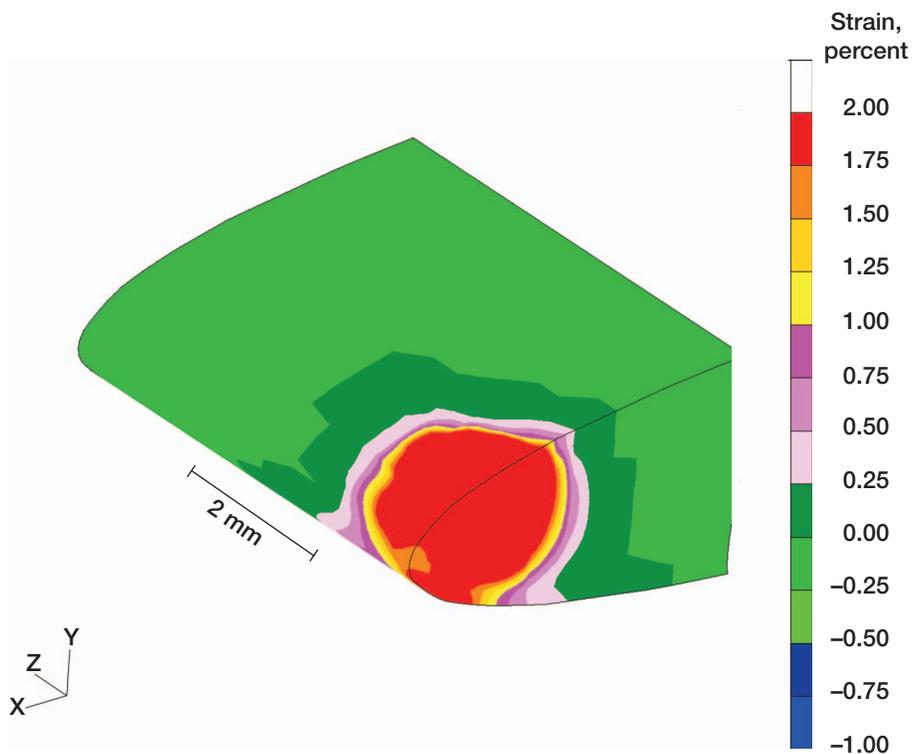
Figure 33.—Prediction of von Mises plastic strain on front side of Ti-48-2-2 after high-energy impact (specimen 009-08-2).

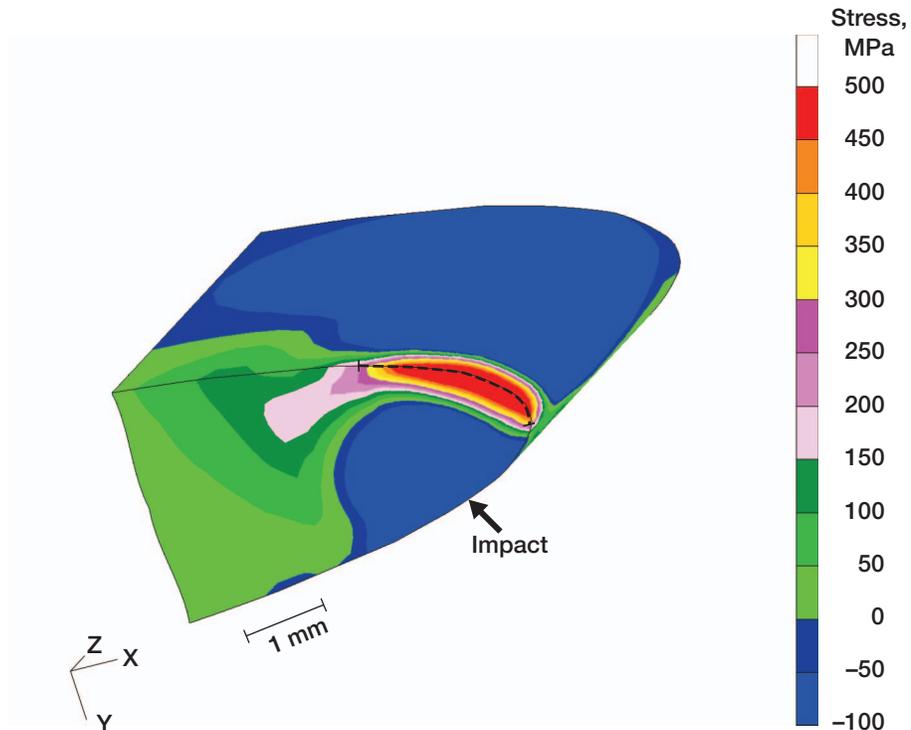
Figure 34.—Prediction of z stress on back side of Ti-48-2-2 after high-energy impact (specimen 009-08-2). Dashed line is cracking zone.

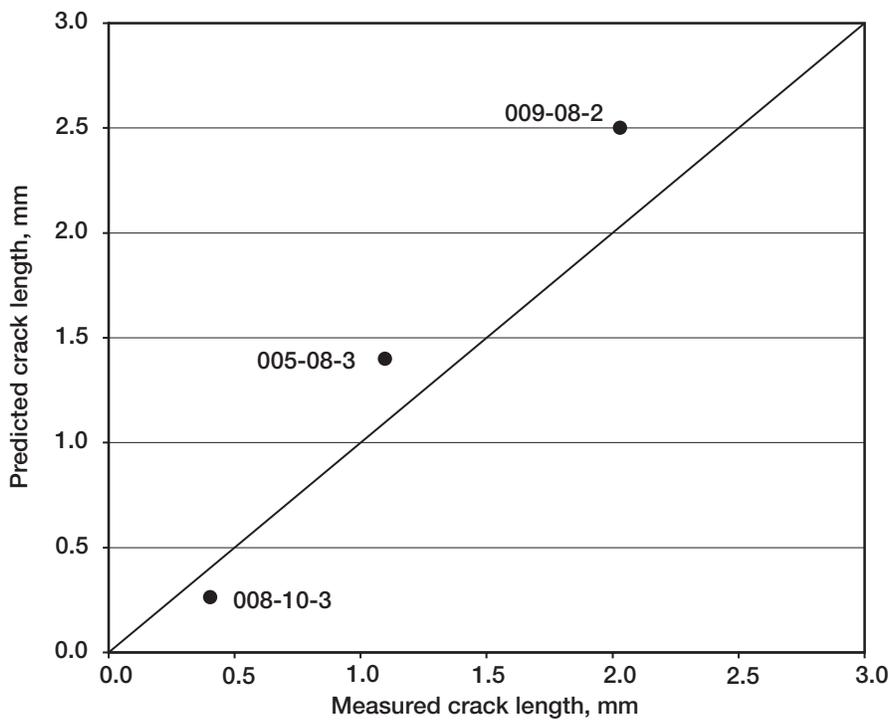
Figure 35.—Prediction capabilities of model for back-side crack lengths of Ti-48-2-2 specimens.

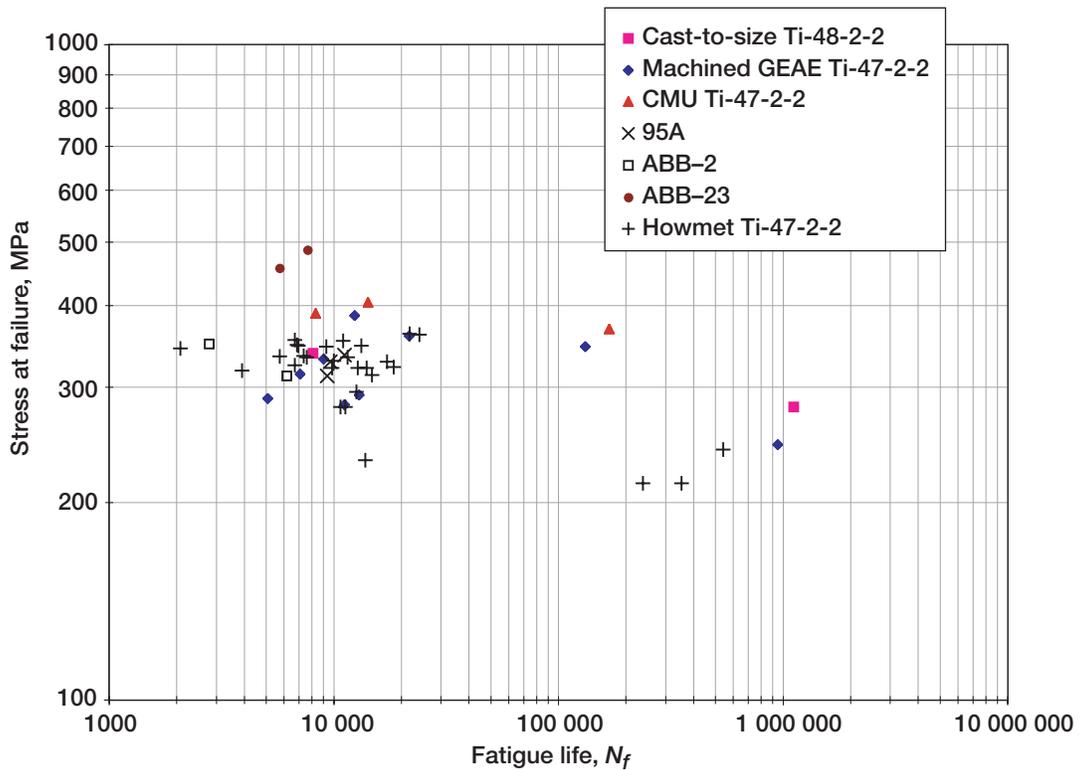
Figure 36.—S–N data for various  $\gamma$ -TiAl alloys. Virgin samples, 650 °C, load ratio  $R_\sigma = 0.05$ , defect area  $< 0.1 \text{ mm}^2$ .

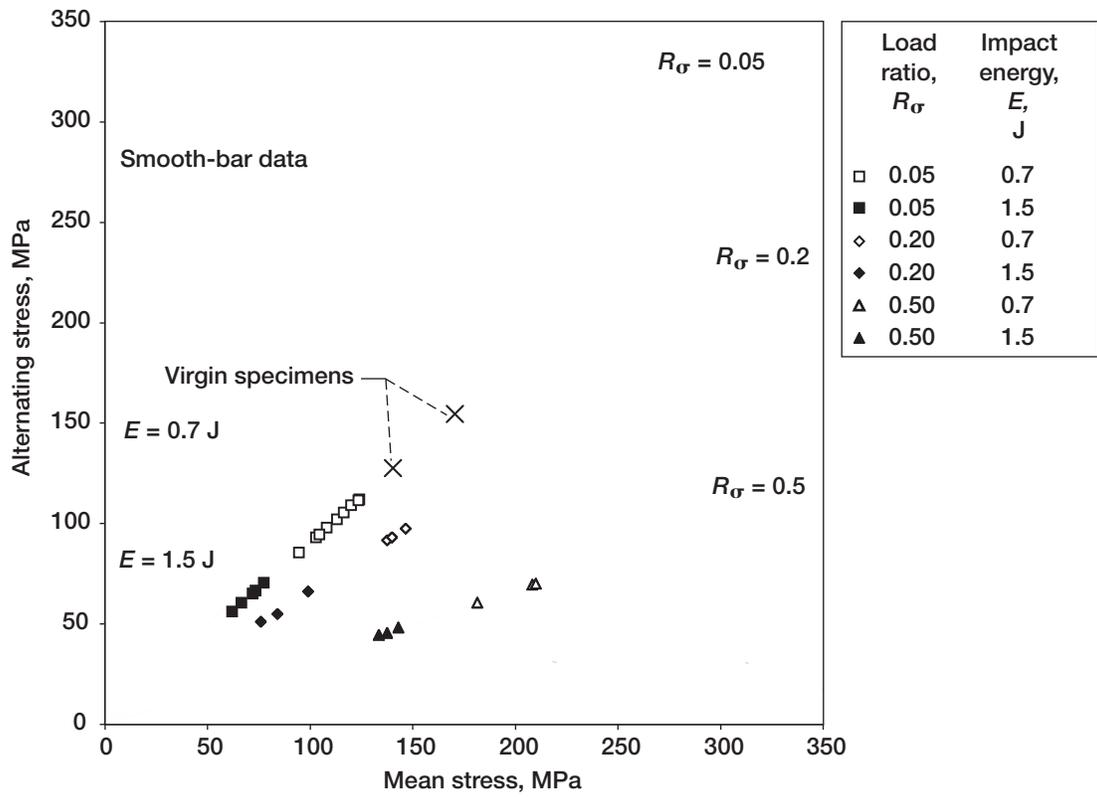
Figure 37.—Tensile mean stress relationships of cast-to-size Ti-48-2-2 with 0.2 percent offset yield strength of 284 MPa and ultimate tensile strength of 474 MPa. Smooth-bar data are from Ti-48-2-2 specimens tested at GEAE.

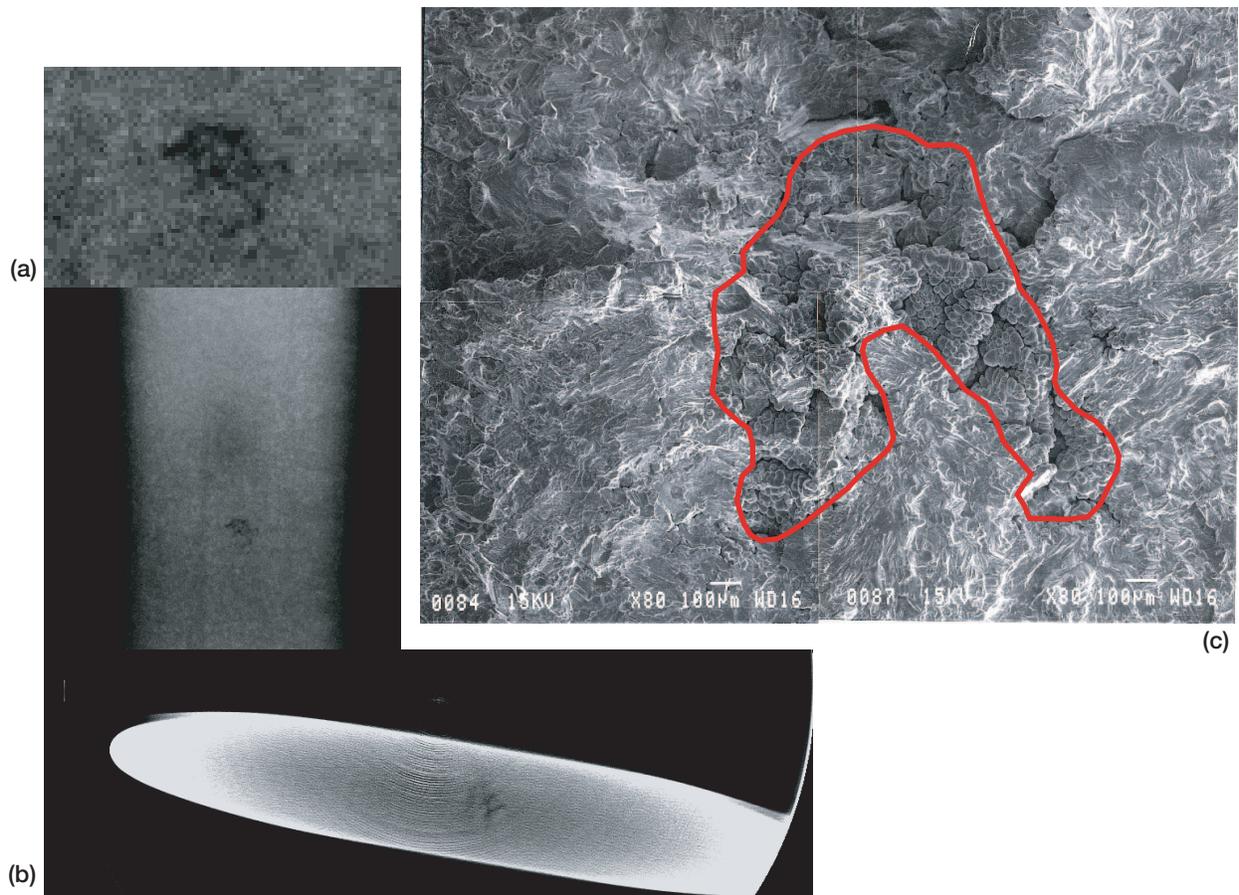
Figure 40.—Nondestructive evaluation identification of casting defect that initiated fatigue cracking.  
(a) Microfocus x-ray. (b) Computed tomography scan of cross section. (c) Scanning electron microscopy image of fracture surface (porosity outlined).

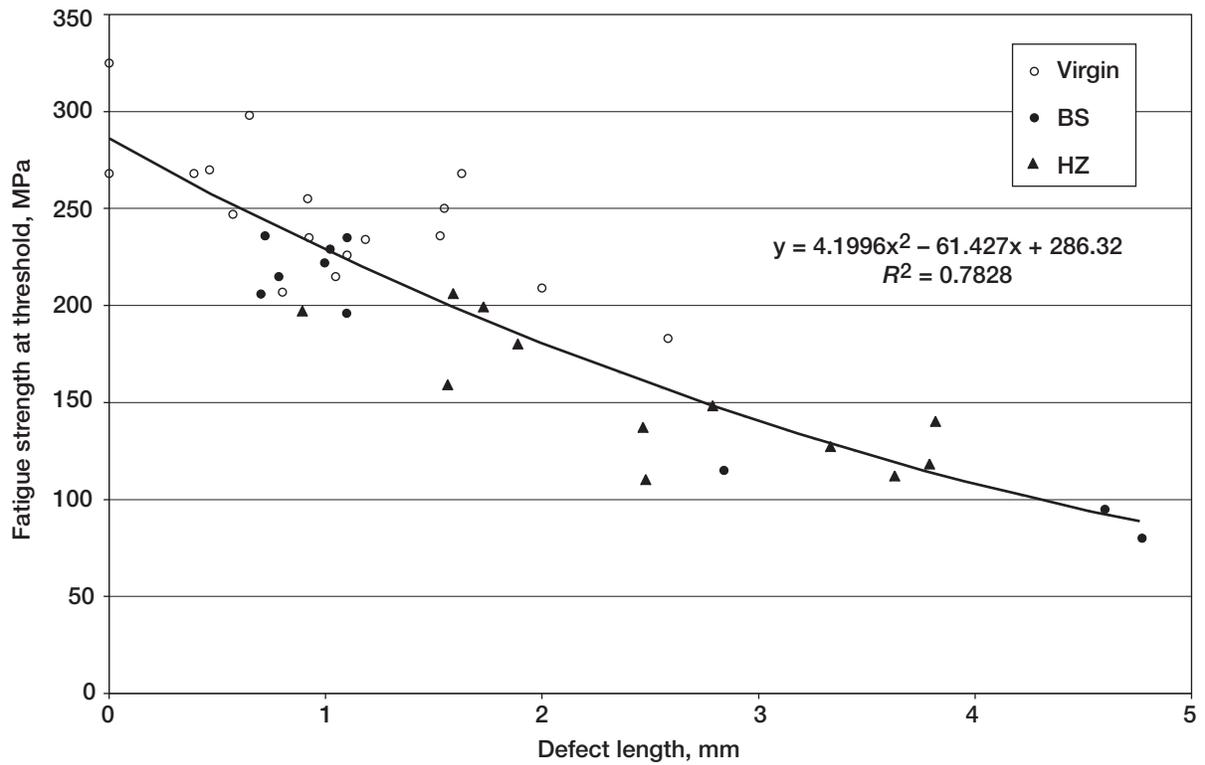
Figure 41.—Fatigue strength at threshold as function of defect length for cast-to-size Ti-48-2-2.

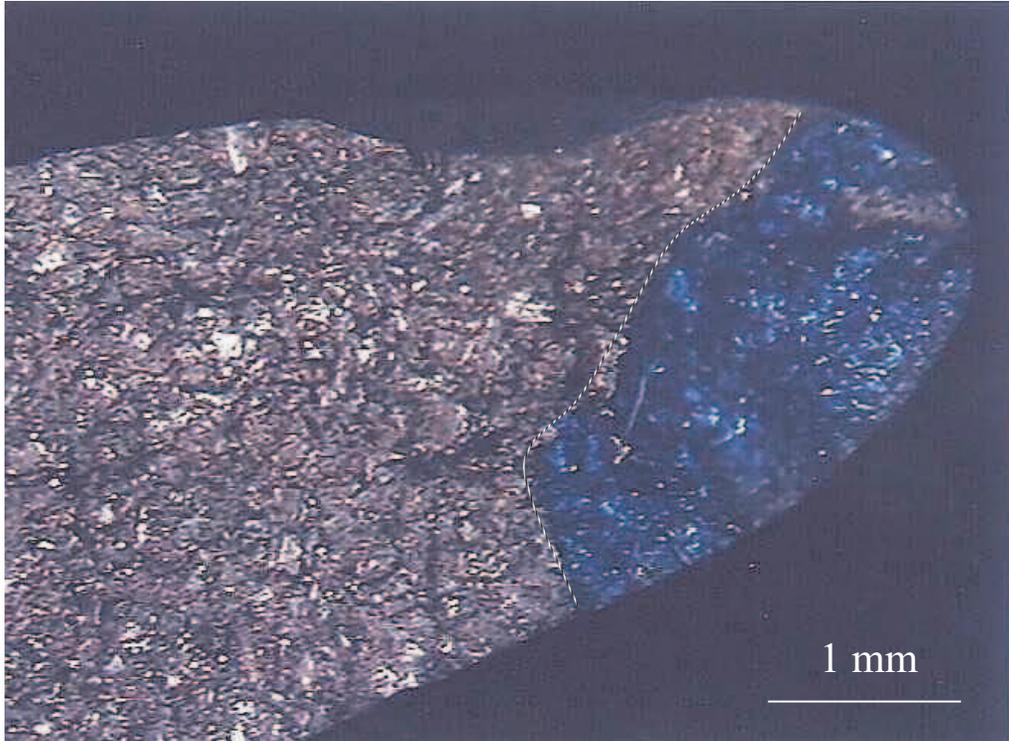
Figure 42.—Back-side crack encompassing most of specimen thickness for cast-to-size Ti-48-2-2.

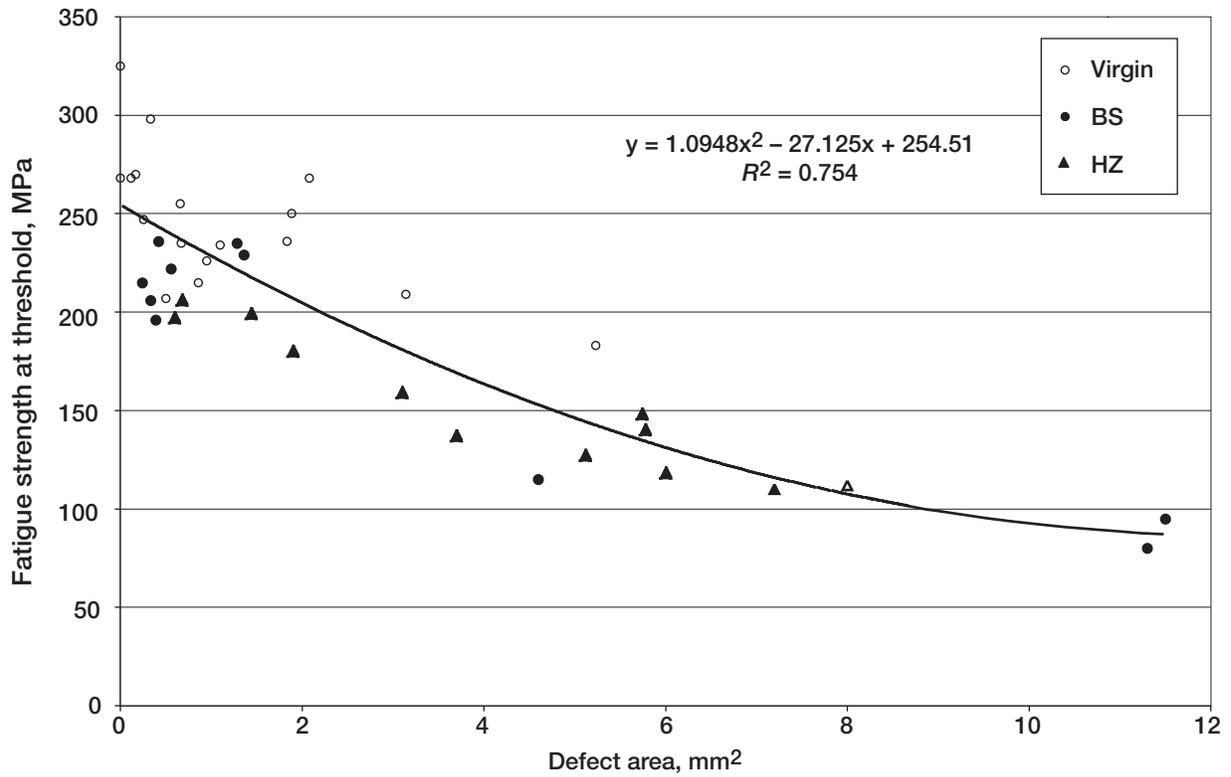
Figure 43.—Fatigue strength at threshold as function of defect area for cast-to-size Ti-48-2-2.

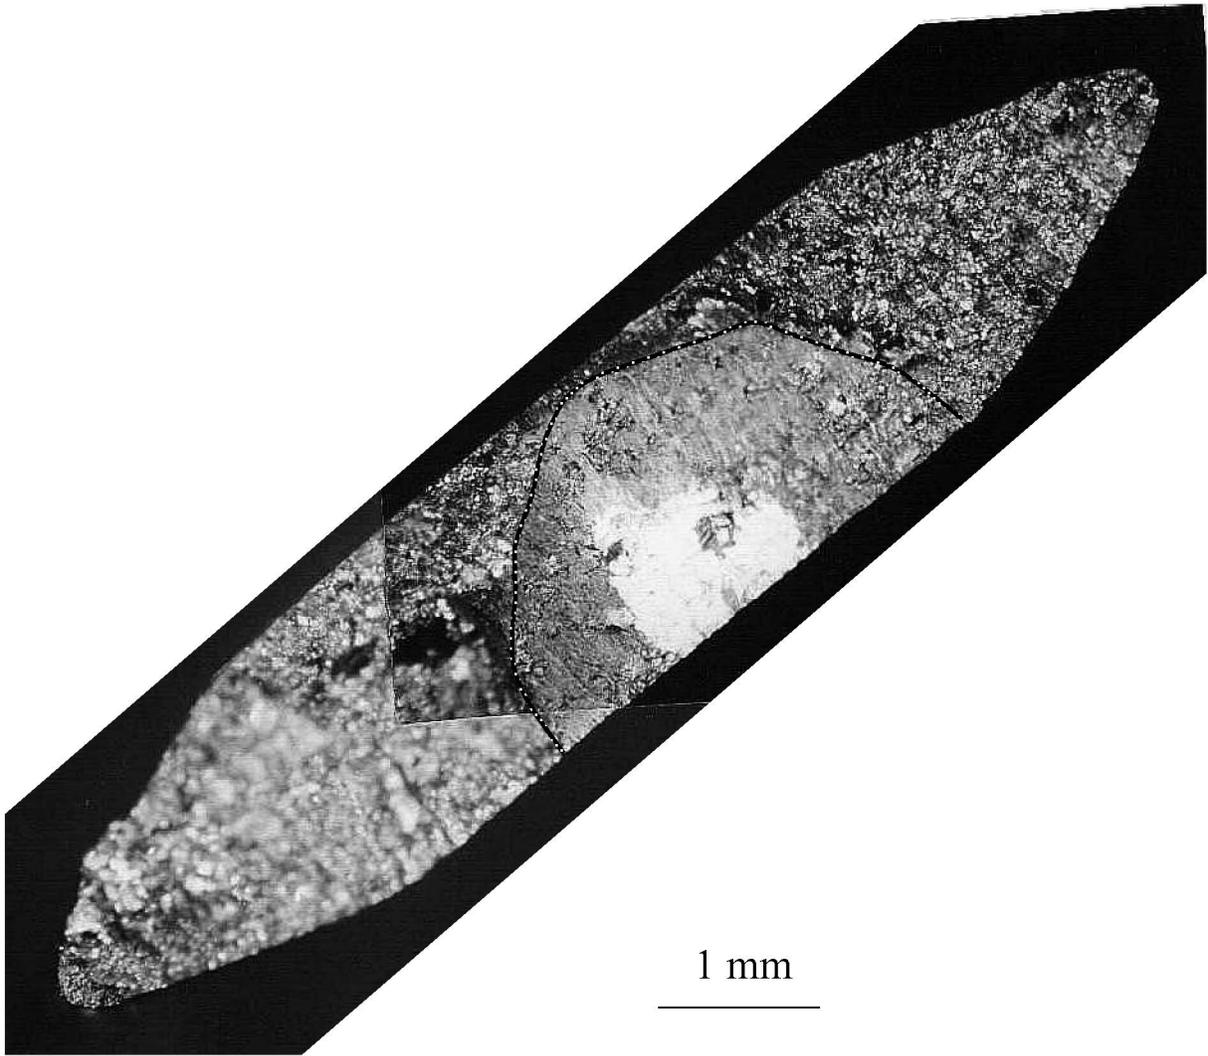
Figure 46.—Large interlamellar crack resulting in low fatigue strength for machined GEAE Ti-47-2-2.

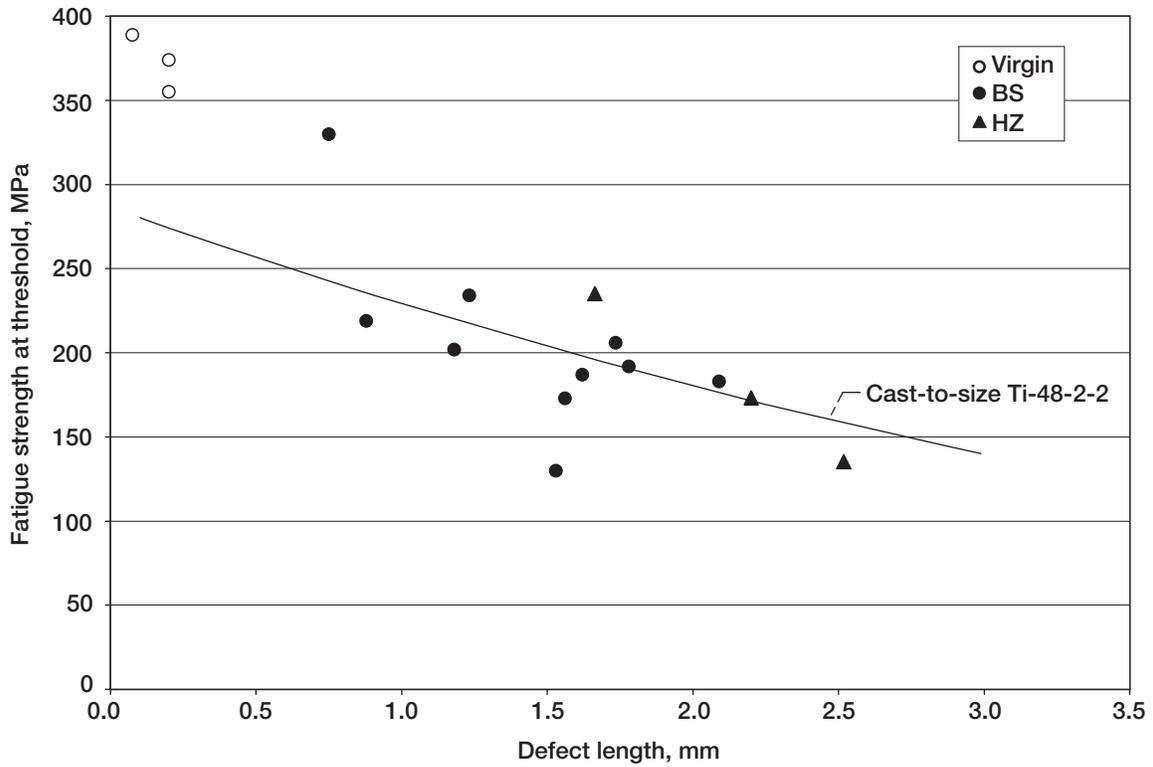
Figure 47.—Fatigue strength at threshold as function of defect length for CMU Ti-47-2-2.

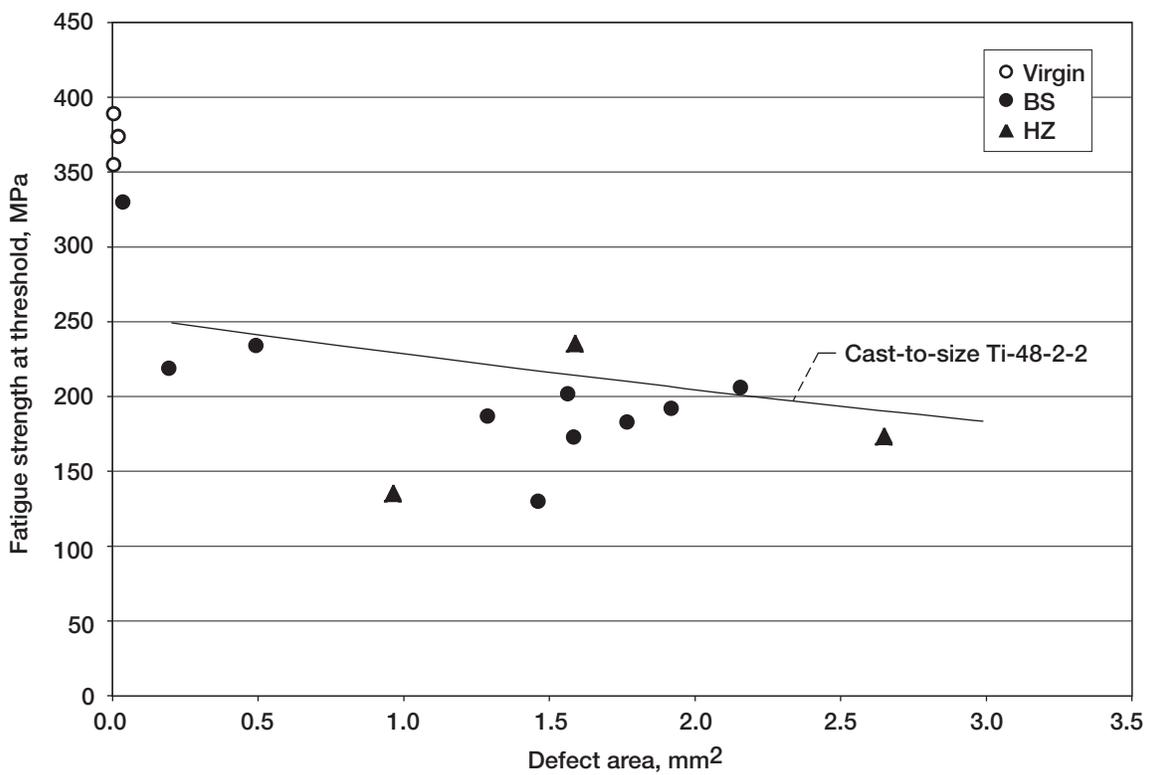
Figure 48.—Fatigue strength at threshold as function of defect area for CMU Ti-47-2-2.

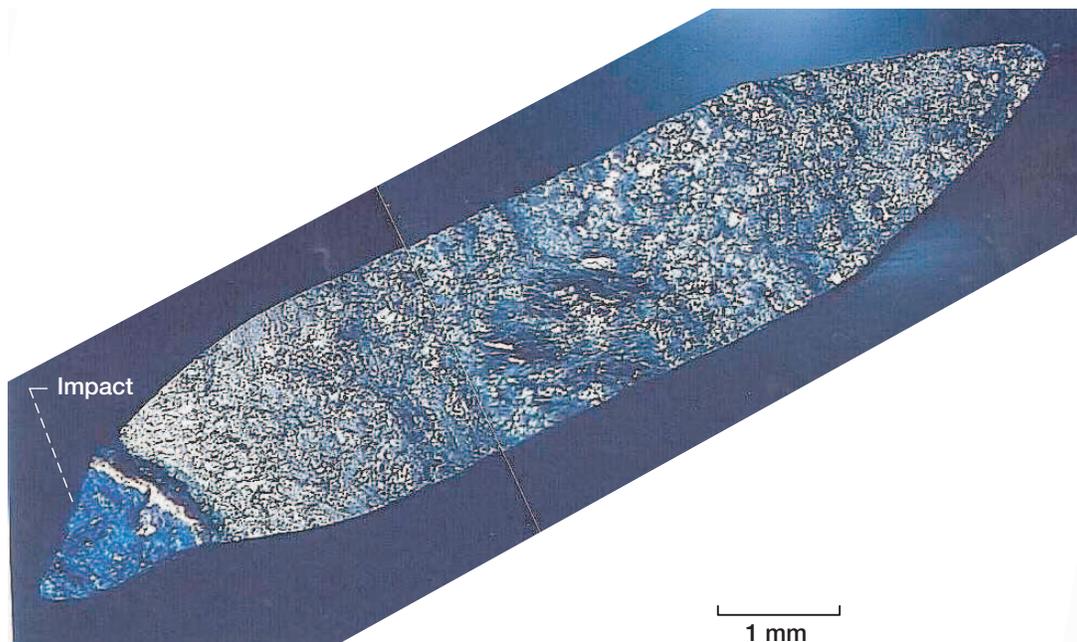
Figure 49.—Bent leading edge of CMU Ti-47-2-2 sample.

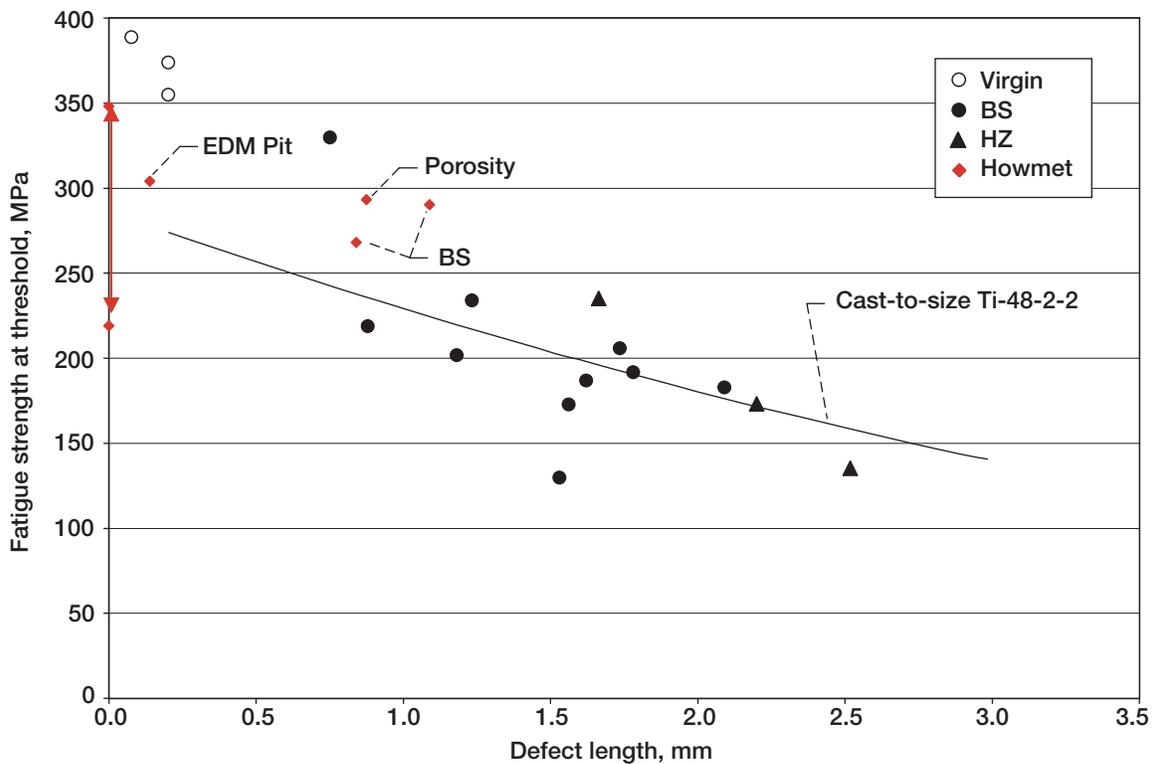
Figure 50.—Fatigue strength at threshold as function of defect length for CMU and Howmet Ti-47-2-2 low-aluminum alloys.

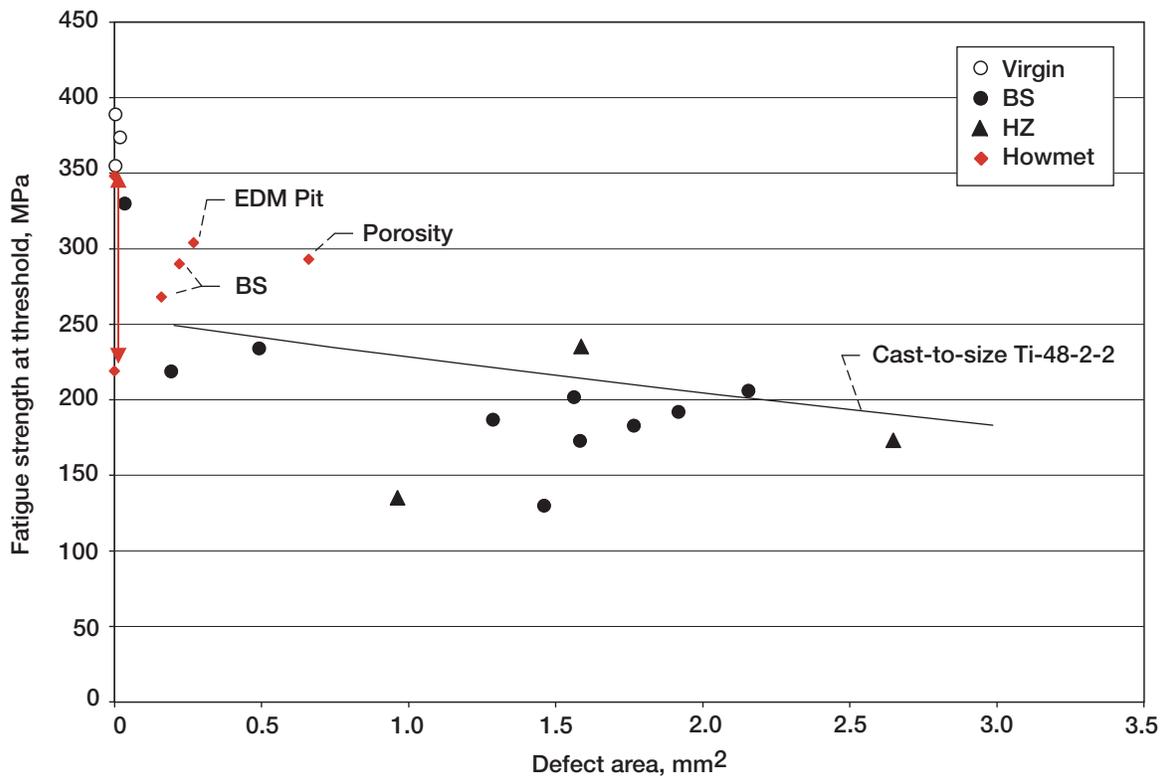
Figure 51.—Fatigue strength at threshold as function of defect area for CMU and Howmet Ti-47-2-2.

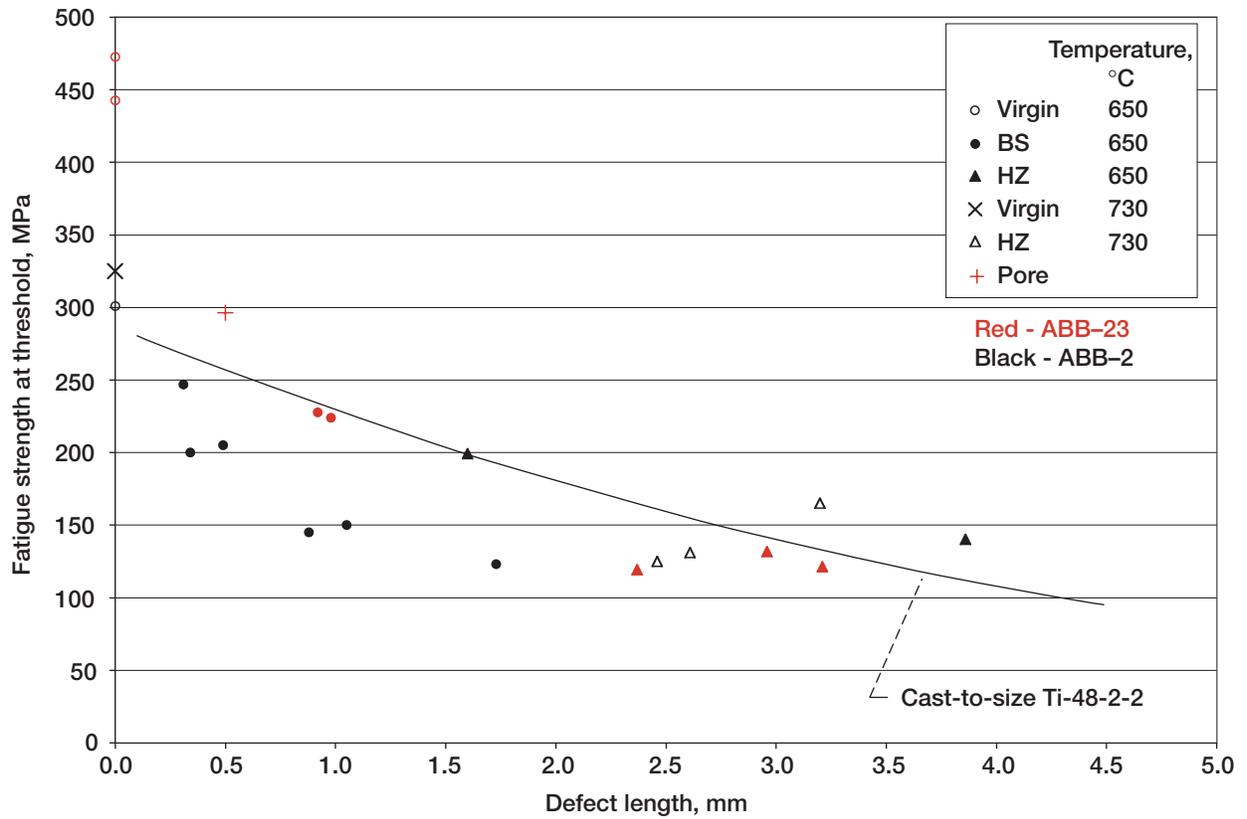
Figure 52.—Fatigue strength at threshold as function of defect length for cast-to-size ABB-2 and machined ABB-23.

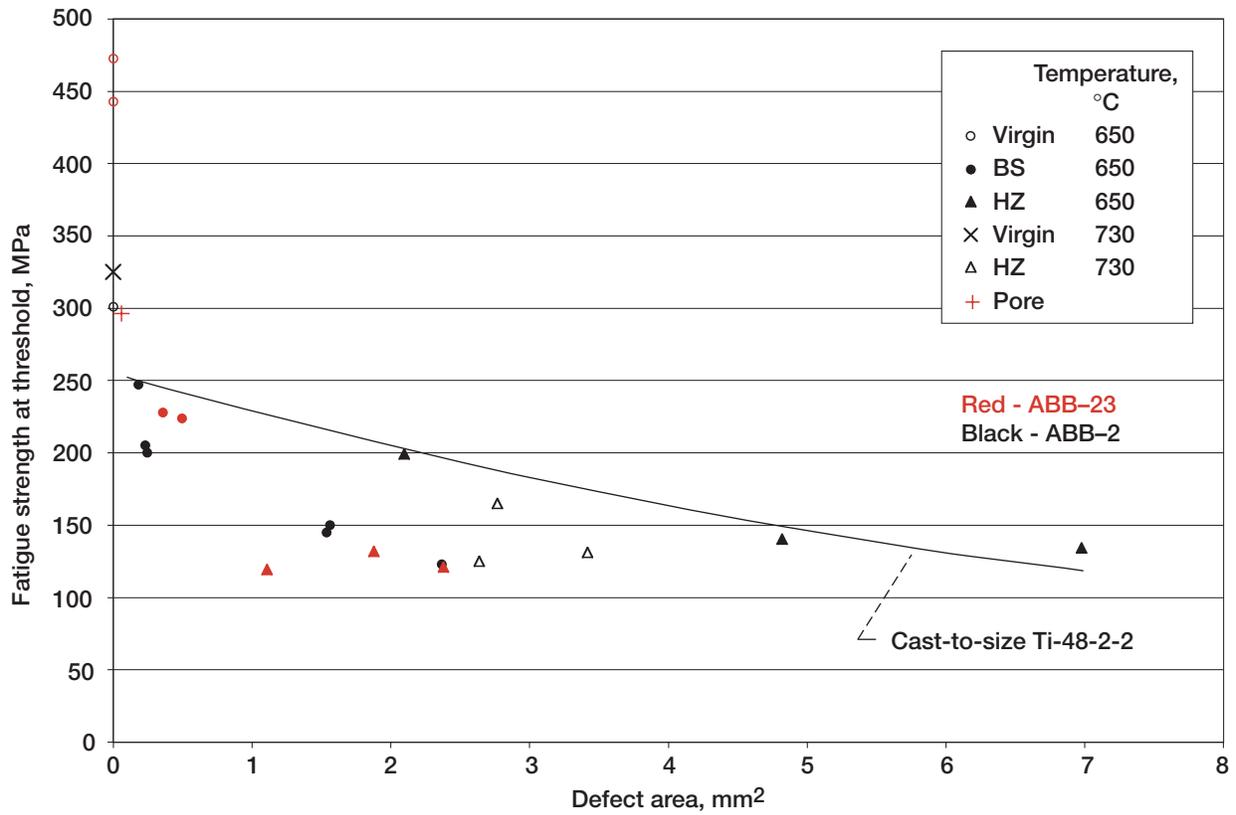
Figure 53.—Fatigue strength at threshold as function of defect area for cast-to-size ABB-2 and machined ABB-23.

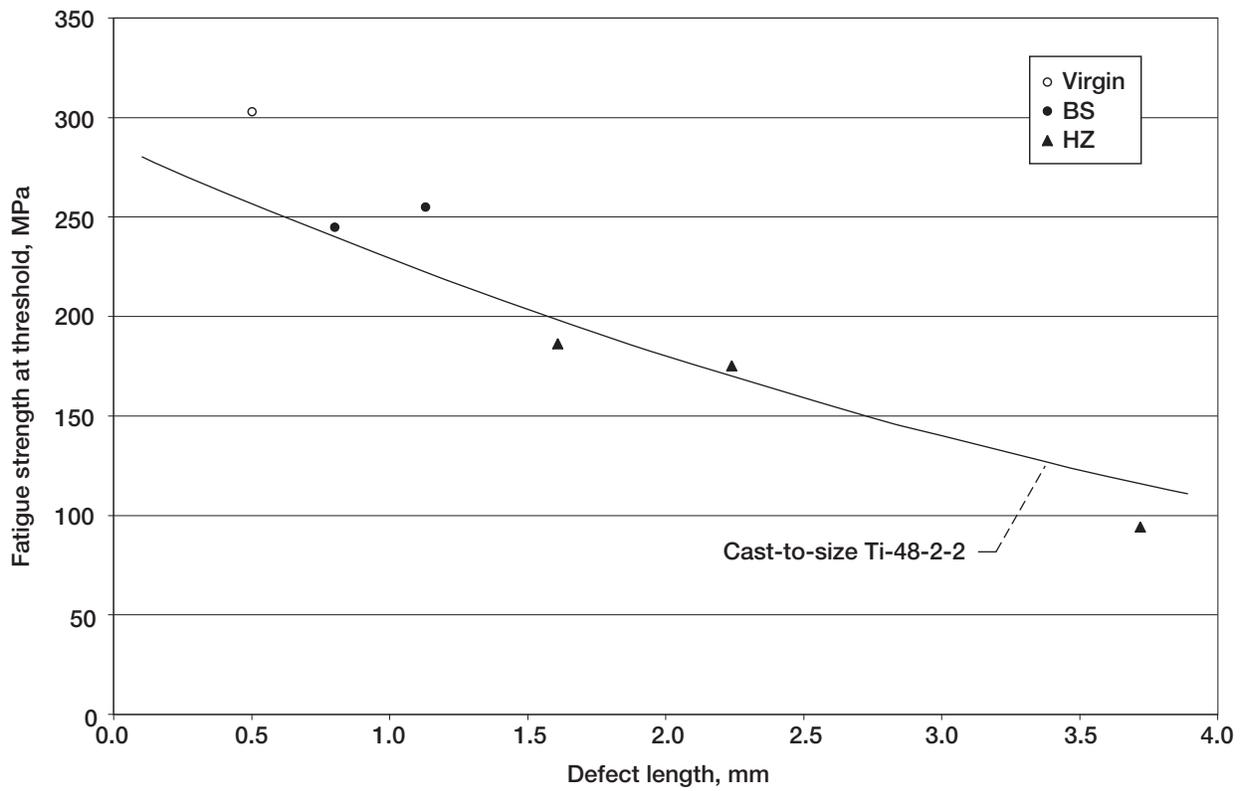
Figure 54.—Fatigue strength at threshold as function of defect length for machined NCG359E.

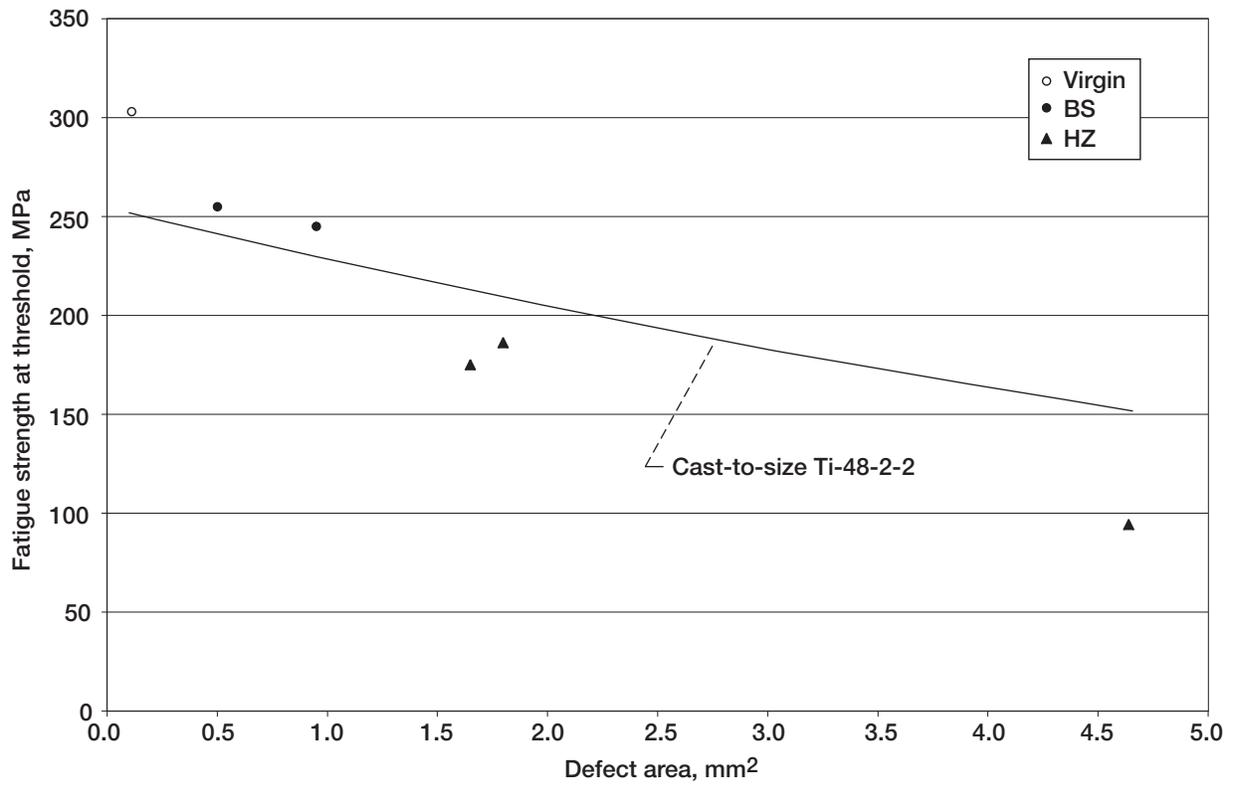
Figure 55.—Fatigue strength at threshold as function of defect area for machined NCG359E.

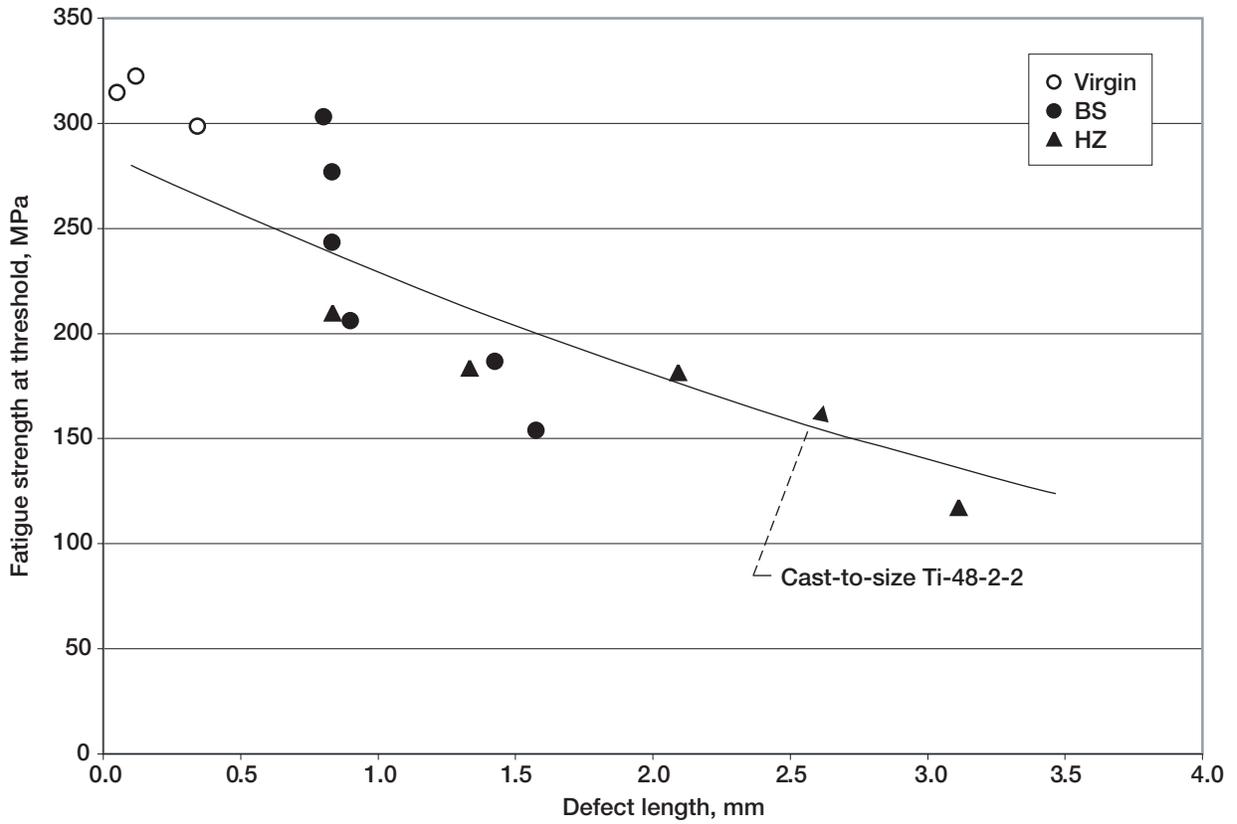
Figure 56.—Fatigue strength at threshold as function of defect length for machined 95A.
